[History](#) > [Agricultural History Project](#) > [Agricultural Field Guide](#) > [Barn Types](#) > Pennsylvania Barn

Pennsylvania Barn

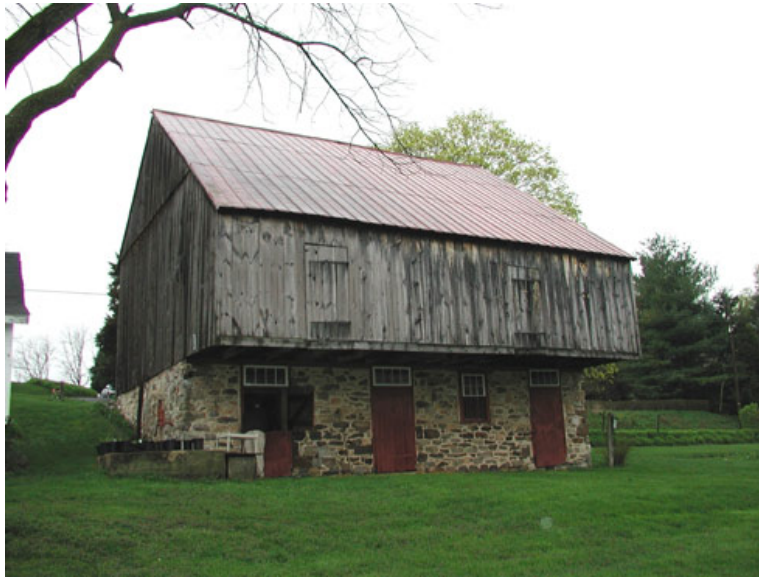
Pennsylvania Barn, Berks County, c. 1820

This barn shows the characteristic forebay, banked construction, and gable roof of the Pennsylvania Barn.

The Pennsylvania Barn's main diagnostic feature is the projecting 7-8 foot forebay, or overshoot. The barn is banked, and organized such that the upper level consists of central threshing floor(s), flanked by mows, and a granary (sometimes in the forebay, sometimes next to a mow on the bank side). The Pennsylvania Barn almost always has a gable roof. On the lower level, stable and stalls (organized crosswise to the roof ridge, separated by alleyways for humans) housed horses, milk cows, beef cattle, and sometimes sheep or hogs.

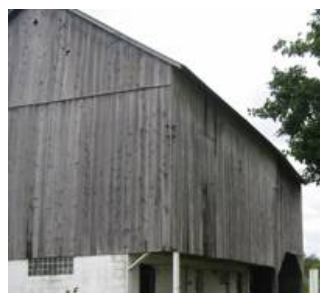
Forebay:

*Pennsylvania Barn showing forebay, Columbia County, c. 1870
This photograph clearly shows the projecting forebay.
In this case, three posts provide support.*

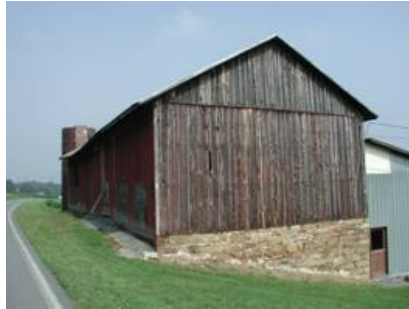
Banked:

*Pennsylvania Barn showing banked construction, Northumberland County, 1845
This barn shows banked construction. Its forebay is enclosed on the gable ends;
that is, the foundation extends to the outer edge of the forebay. The barn has
a gable roof. This barn has a portion of its original log crib still intact and
a date stone of 1845.*

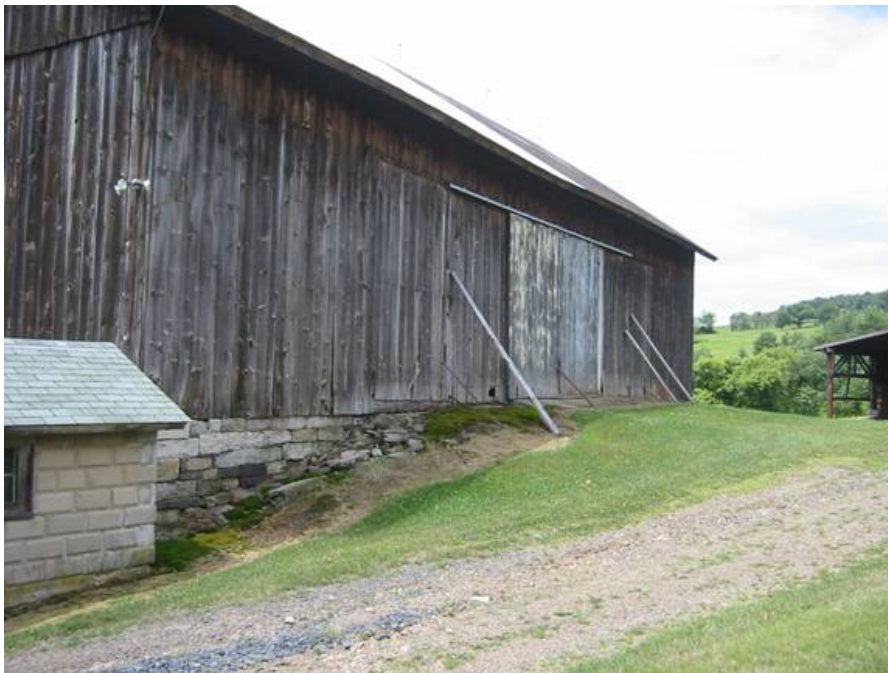
*Pennsylvania Barn showing bank side, Columbia County, late nineteenth century
This bankside view shows how the ramp led to the central floor.
On larger barns, multiple sets of doors led to multiple floors.*

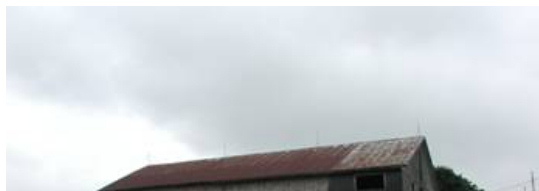
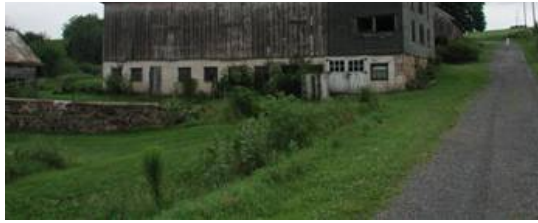
Barn with enclosed forebay, Northumberland County, late nineteenth century original, mid twentieth century alterations

Here is an example, from Lower Mahanoy Township, Northumberland County. This barn forebay has been fully enclosed with concrete blocks across its entire length. Clues about the enclosure include newer materials; the forebay end-wall on the gable end; and the rows of windows in the new concrete block wall, a characteristic of dairy housing. Very likely the interior of this barn has been re-worked, too (the end nearest the road was altered top to bottom for poultry housing). Another common alteration of a Pennsylvania Barn was to turn it into a three-gable barn.

Many Pennsylvania Barns started life with a forebay, but as agricultural conditions changed, they were altered, sometimes such that the diagnostic forebay disappeared, and the characteristic crosswise basement organization also was altered, usually with the installation of lengthwise stanchions for dairy cows. These alterations usually date to the early decades of the 20th century. Look for evidence that there was once a forebay. This could include foundation walls that extend to the front downslope wall and support it, but are of a different material (usually stone) than the new wall enclosing the forebay; new materials used to enclose the forebay; a seam between where the forebay formerly stopped and the new wall; evidence for a former partition where the "Dutch" doors and wall would formerly have been located; on the upper level, evidence in the framing showing that the new wall was attached after the original framing was installed.

On the interior, alterations could be numerous, but look for concrete floors, evidence of stanchions, and windows and doors cut into the gable ends.
